SURGICAL TREATMENT OF A NON HEALING PERIAPICAL PATHOSIS THROUGH APICOECTOMY & MANAGEMENT OF ASSOCIATED VERTICAL ROOT FRACTURE USING BIODENTINE – A CASE REPORT

Case of the Month – February 2018

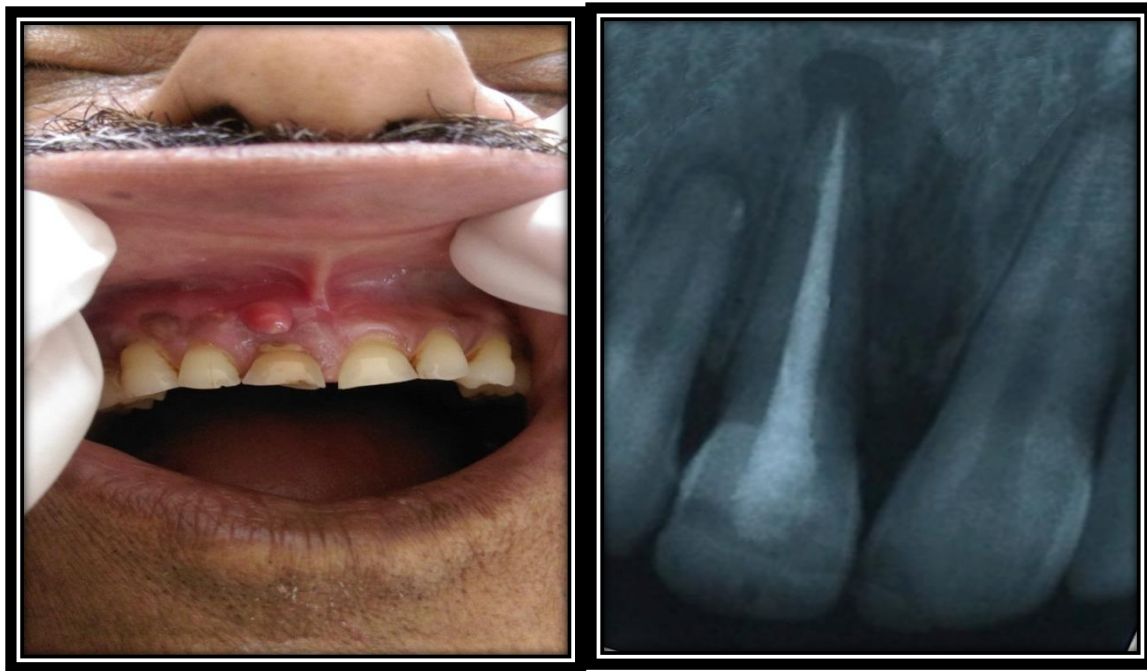
FIGURE-1FIGURE-2

O/E – a gingival swelling was observed at the periapical area of tooth 11, patient gave H/O RCT done on 11, one year back outside the institution. (fig-1)

On radiograph examination tooth 11, showed complete obturation of the canal with a persistent periapical radiolucency. (fig-2)

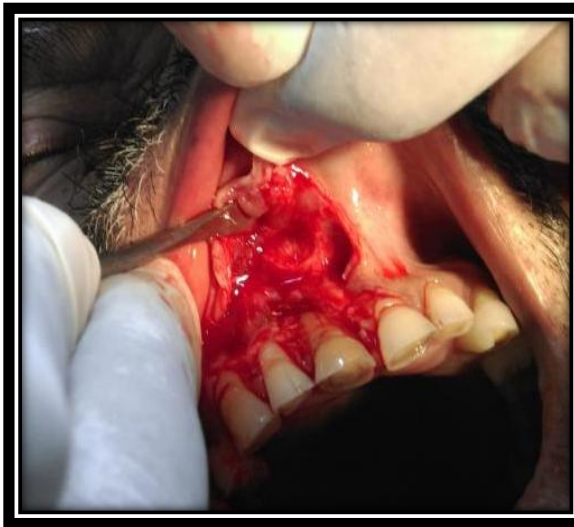
FIGURE-3

Since conventional RCT failed, we went for Retreatment. But the lesion didn't resolve after Re-Treatment, following which an Apicoectomy was planned for the tooth. (fig-3). Upon raising the flap, VRF was observed. (fig-4). Apicoectomy was 1st completed for the concerned tooth with proper retrograde restoration. For managing the VRF a trough was made along the fracture line for VRF restoration. Biodentin was placed on it (fig-5). An alloplastic bone graft was placed in the defect and flap was successfully sutured back (fig-6). Post operative x-ray of the concerned tooth was taken (fig-7). A 3 month and 6 month follow up of

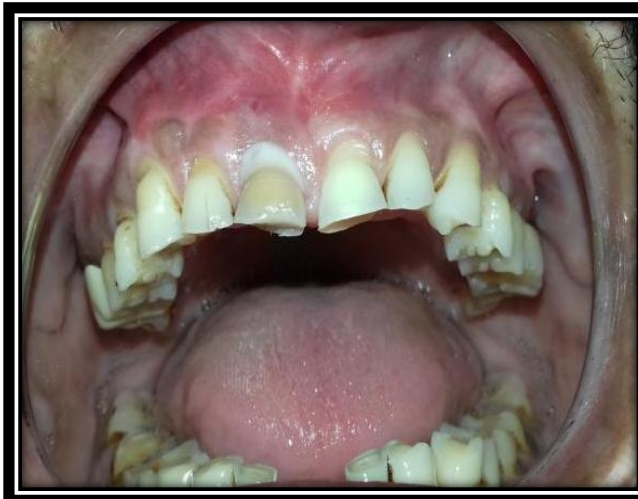
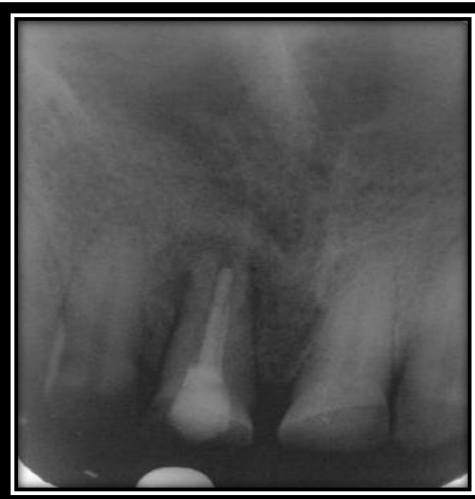
FIGURE-8

the case revealed a considerable healing of the lesion with no complaint of pain from the patient(fig-8 &9).
