Case of the Month – November 2017

CLINICAL MANAGEMENT OF CROWN AND ROOT FRACTURE OF UPPER ANTERIOR TEETH – A CASE REPORT

Author; Dr.M. RAJASEKARAN

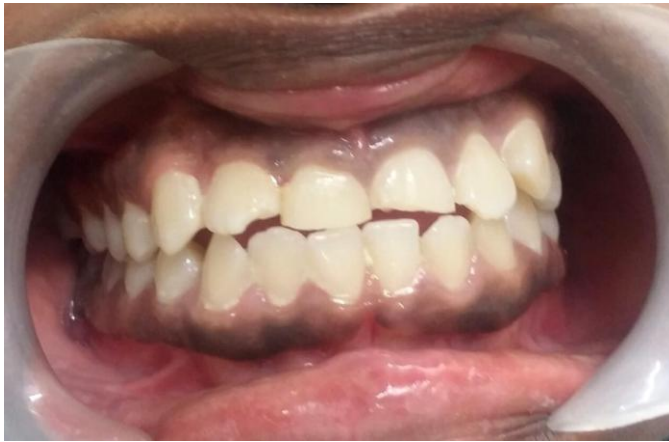
Fig 1

A 21-year-old female patient reported to the dental clinic following trauma to the maxillary anterior region due to road accident two days back (**Fig 1**). She complained of fractured maxillary incisors and presented a desire to get them restored in order to have an aesthetic smile. Clinical examination of the patient revealed complicated crown fracture of the upper incisors. A radiograph of the maxillary anterior region illustrated horizontal root fracture at the middle third of the upper Left central incisor (**Fig 5A**). Clinically mobility of the coronal fragment was evident. On the other hand, the roots of the upper right central and lateral incisors were intact. Radiographically fracture was observed in right central incisor involving pulp thus root canal therapy was planned for it too. Lateral incisors also showed a crown fracture but no pulp involvement was seen, hence no root canal therapy was performed in these two laterals but a ceramic crown was planned later along with central incisors for better functionality and esthetics.
