# Aesthetic Management of Uncomplicated Crown Fracture using Direct Composite Restoration: It's Dent(art)istry.

Introduction of the Case:

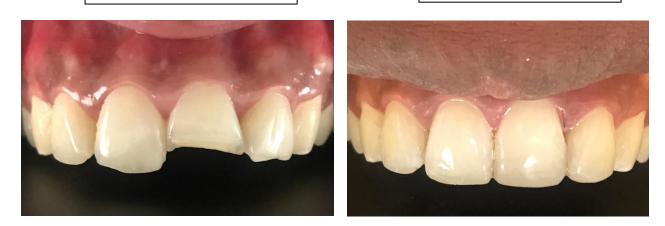
## 9. PREOPERATIVE

A 22 year old male patient named Mr Avinash reported with the chief complaint of trauma to his upper front tooth 1 month ago. Clinical examination revealed fractured 21 and 22. The distoincisal surface of 11 was worn out due to attrition. (Fig 1)

Thorough Oral prophylaxis was done for the patient. The patient was reviewed after 1 week to assess the gingival health. Shade selection was done and chosen as A2. Under rubber dam isolation, (Fig 3) beveling was done for 21 and 22. Palatal beveling was done at 45 degree angulation. (Fig 4) Labial beveling was done in two planes: short bevel at 45 degrees angulation followed by partial bevel at 10 degrees. (Fig 5) The distoincisal edge of 11 was roughened with a fine grit diamond abrasive. Acid etching was done with 37% Orthophosphoric acid for 15 seconds rinsed thoroughly and dried. GC Solare self etch Universal Bonding agent was applied to the etched surfaces and allowed to air dry for 10 seconds followed by light curing for 20 seconds. The silicone putty index made from the diagnostic mock up was used for building the palatal surface. (Fig 6 & 7) Composite build-up was done with Shofu Rainbow kit. The labial view of the completed restoration is shown in fig 8 and 10.

Anterior tooth fractures can be managed by various treatment modalities like direct composite restoration, full coverage porcelain laminate veneers or ceramic crowns based on the involvement of tooth structure. For minimal tooth loss, direct composite restorations are a viable option as they are less time consuming, economic and durable with good aesthetic outcome. Solare Sculpt is a high strength universal composite with self polishing ability and has the ability to exhibit chameleon effect. The entire aesthetic restoration can be finished with a single shade of composite due to the incorporation of dispersed nanofillers which have light scattering properties and reflects the colour of the adnexal tooth structure. The bonding was accomplished by Solare Universal bond which is a self etch universal adhesive which is versatile can be used with self etch, selective etch and total etch techniques. This case was managed with total etch technique as majority of the bonding surface involved the enamel. A2 shade Solare composite for 11,21 and 22. Finishing of the restoration was done with fine grit diamond abrasives and polishing was done with Shofu Rainbow kit.
