A REASON TO SMILE

Abstract:

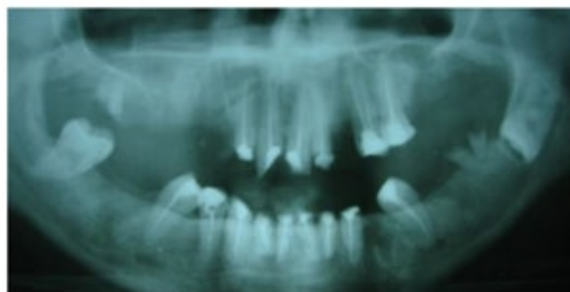
The medical history presented with a history of rheumatoid arthritis for which she is undergoing treatment since childhood. Intra-oral examination revealed grossly destructed tooth structure with missing upper and lower posterior teeth (FIG I). After thorough examination, OPG was taken and the treatment protocol was explained to the patient in detail. After informed consent, endodontic therapy was carried out in 12, 11, 21, 22, 24, and 25 in the upper arch and in the mandibular arch root canal therapy was performed in 35, 34, 33, 32, 31, 41, 42, 43, 44 and 45 in multiple visits (FIG II).

FIG II: OPG – After root canal therapy

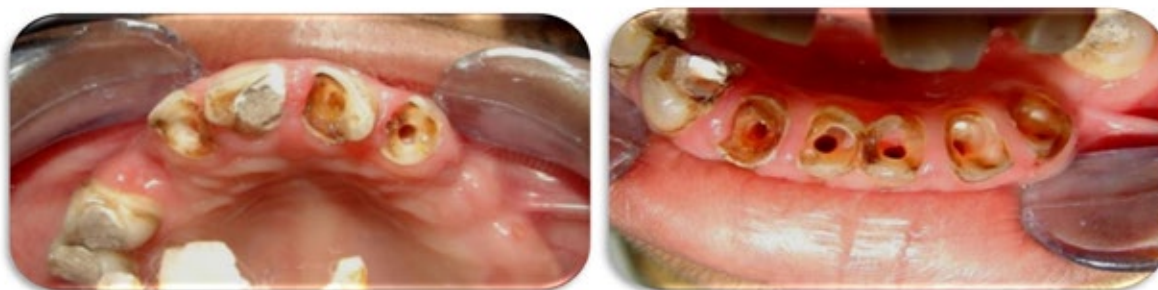
FIG III & IV: Upper and lower teeth post space preparation

The restoration of severely compromised teeth should be based on scientific evidence. Various studies have taken different perspective on this issue. Based Estevas et al (2011), clinical criteria and guidelines, on her following visit, post space preparation was carried out in 12, 11, and 22 and also in the lower anteriors (42, 41, 31, 32, 33) (FIG III & IV). This classification enables the clinician to identify and classify extensively damaged teeth, which in turn helps to assess proper treatment plan and prognosis. Prefabricated glass fiber post (Reforpost, Angelus, Brazil) was luted in place with Multilink resin cement (Ivoclar Vivadent) and core build up was done with Z 350 (3M). On her next consecutive appointment, tooth preparation of both upper and lower teeth was done. Following tooth preparation, bite registration was done (EXABITE II; GC Corp., Tokyo, Japan) (FIG V & VI).

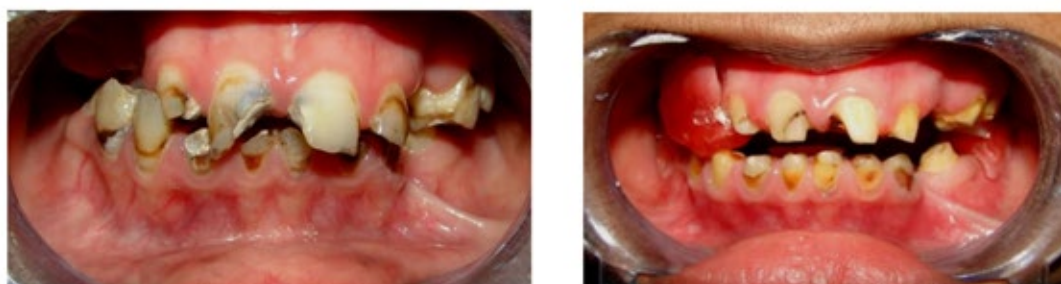
FIG V & VI: Increased interocclusal space

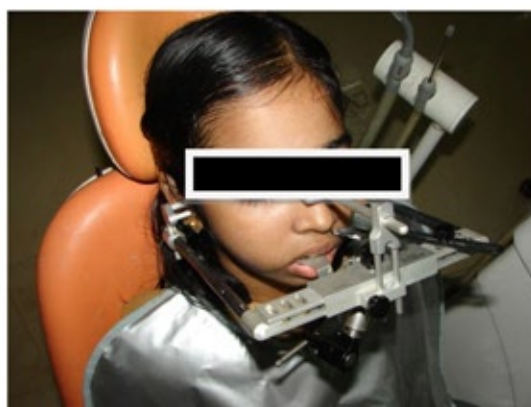
Then the patient's centric relation was recorded using UTS face bow (FIG VII) and the recorded relation was transferred to a semi-adjustable articulator (Stratos 300). Then a mock wax up was done, which was fabricated with heat cure acrylic (FIG VIII & IX).

FIG VII: Face Bow transfer

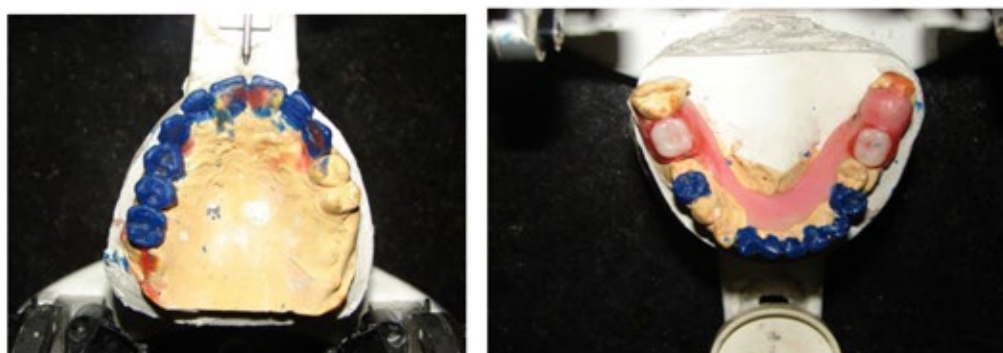
FIG VIII & IX: Upper and lower wax-up

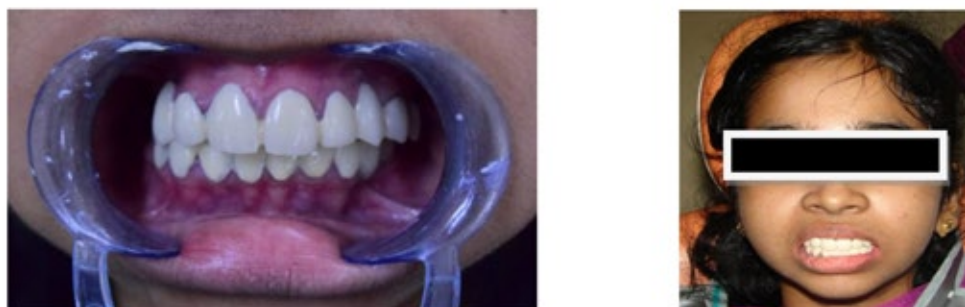
The patient's tooth preparation was temporized for 2-3 weeks. After 3 weeks of temporization, final impression was taken. Repeat bite and centric relation was recorded for confirmation. Then the final prosthesis, porcelain fused ceramic bridge was processed and luted with glass ionomer cement (FIG X & XI).

FIG X & XI: Postoperative view
